International best practice' Middle-Large Scale Biogas-Plant- technology planning, II

Lessons learned from design failures and biogas plants disasters

Torsten Fischer and Dr. Katharina Backes

Krieg & Fischer Ingenieure GmbH

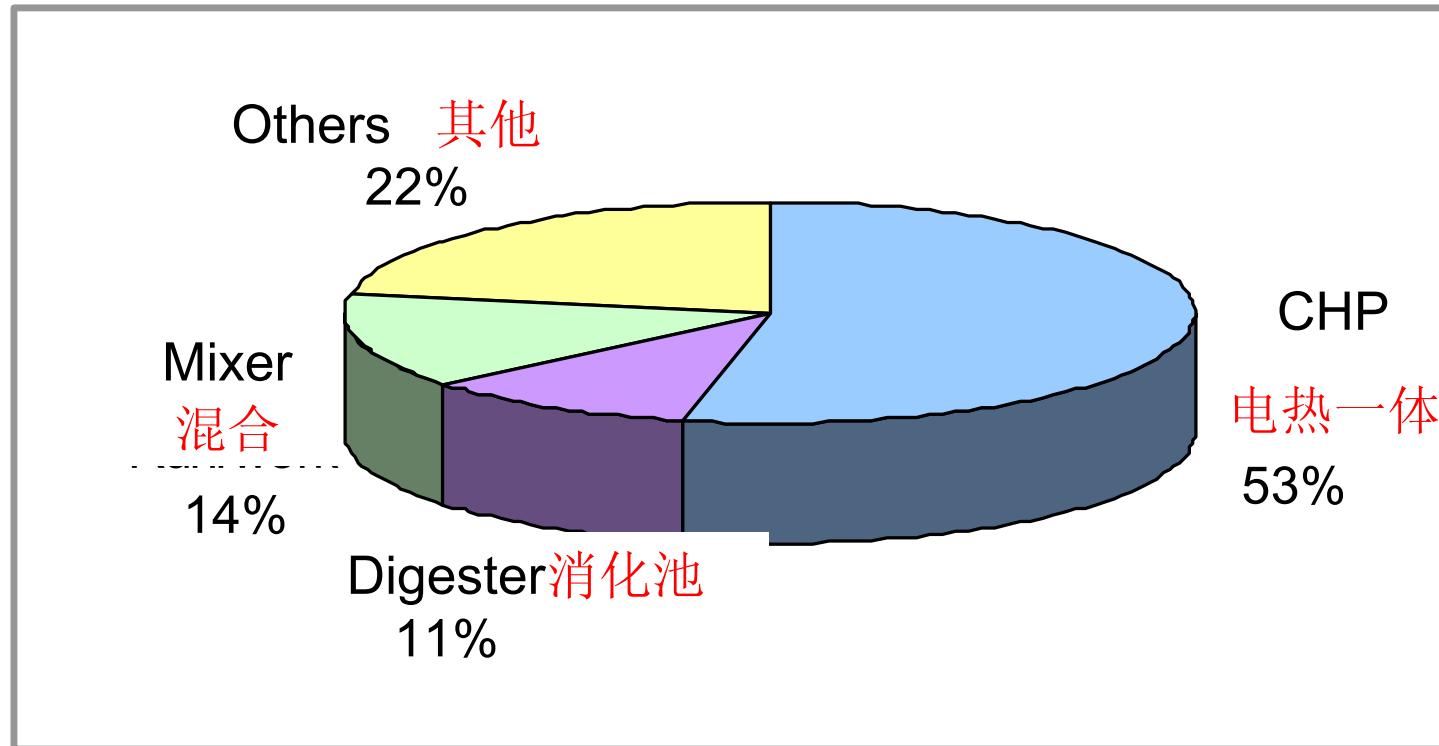
Damages at different parts of the plant
- payments related to different plant parts

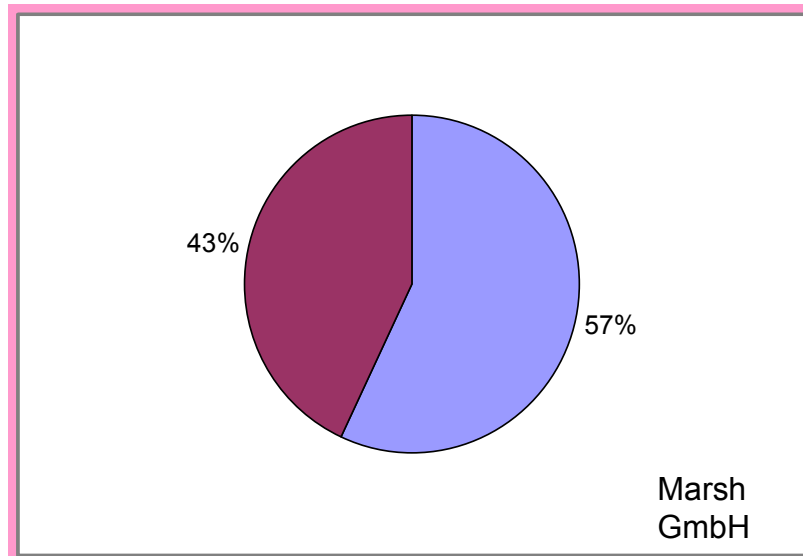
Contracts up to 2005

Part of financial Losses in Digester Damages 消化池损坏的部分经济损耗

■ Damages caused by

Biological Breakdowns 生物降解引起的损害

■ Material Damage 原料破损

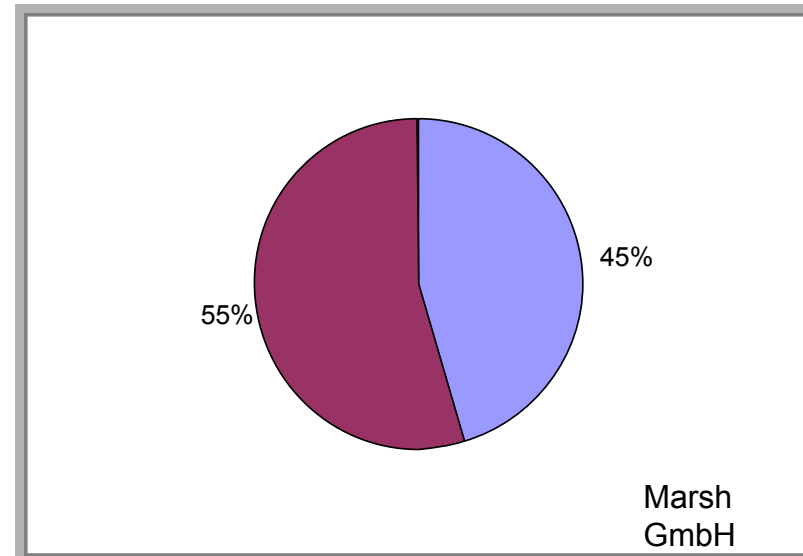
Contracts starting 2005

Insurance of the digester biology becomes more important.

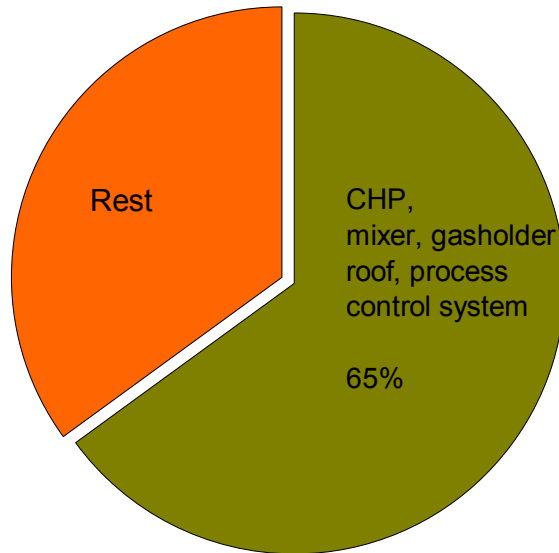
Frequency of damages

- more than 50% of all damages cause payments of less than € 10,000
超过50%的破损得到了不到10,000欧的赔偿
- payments of damages above € 50,000 are paid at 5% of all damages
5%的破损得到了超过50,000欧的赔偿

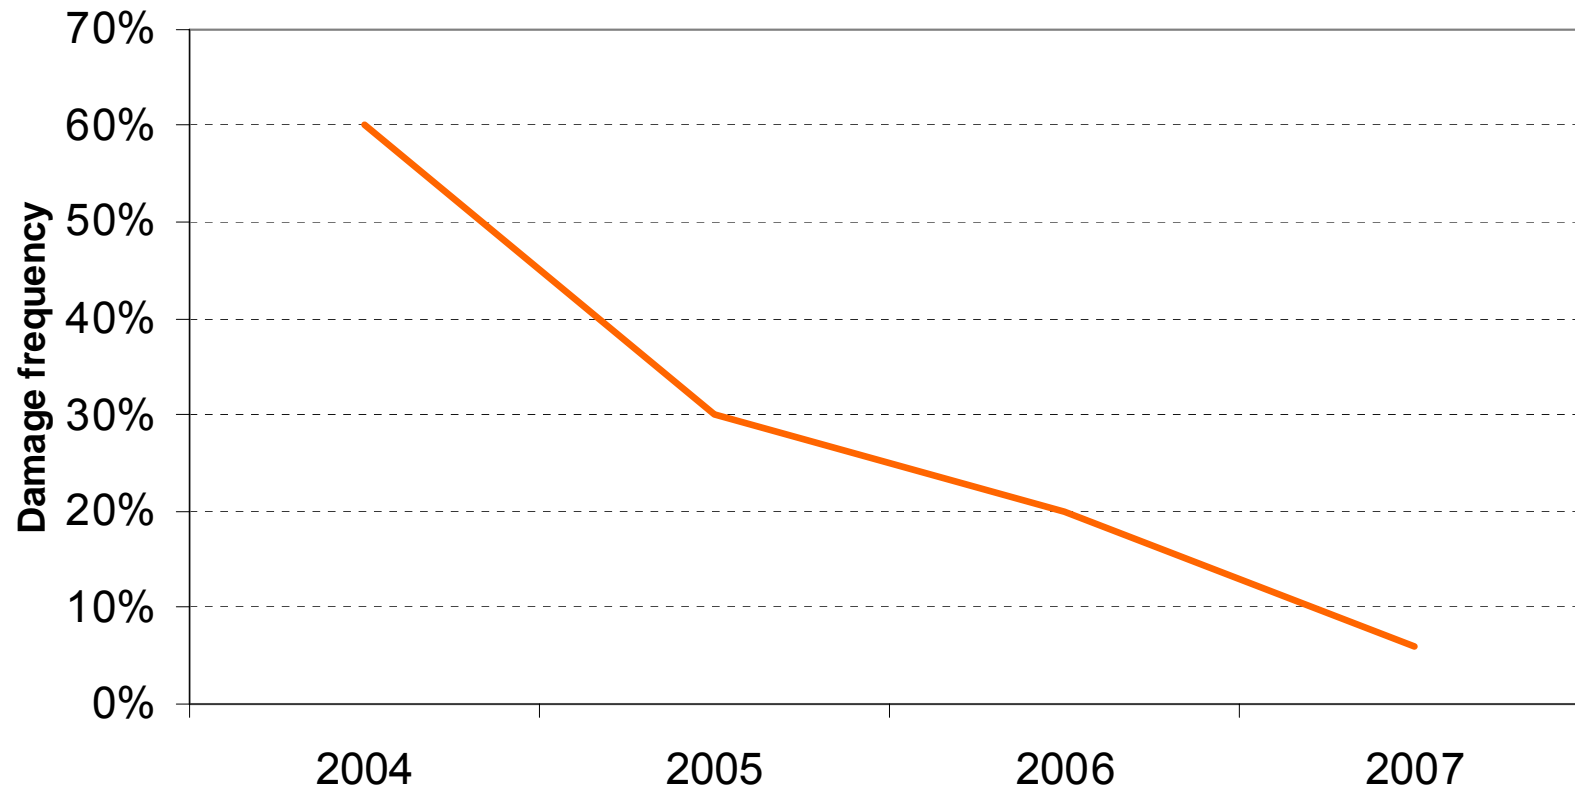
Number of Damages increase disproportionate
to Age of Plant 损坏情况随年份不均匀提高

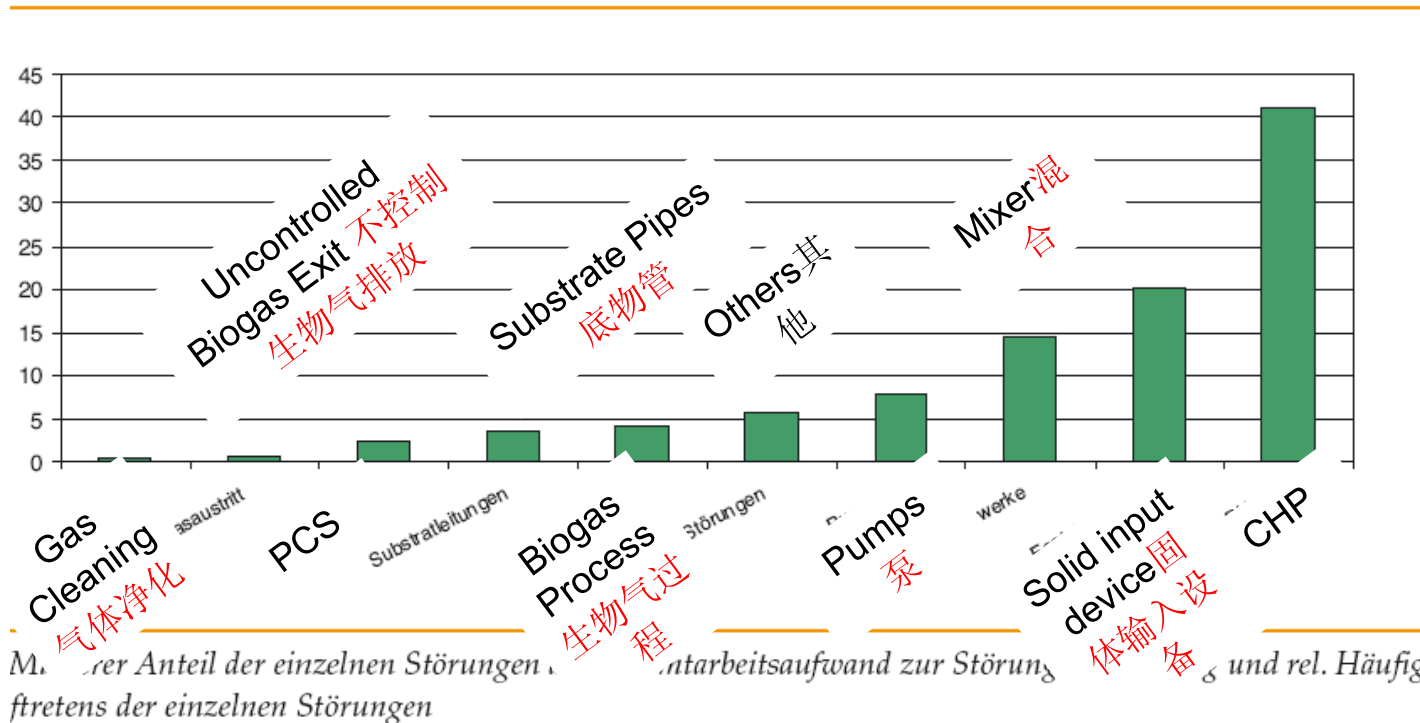
Part of the total amount of work compared to trouble shooting [%]

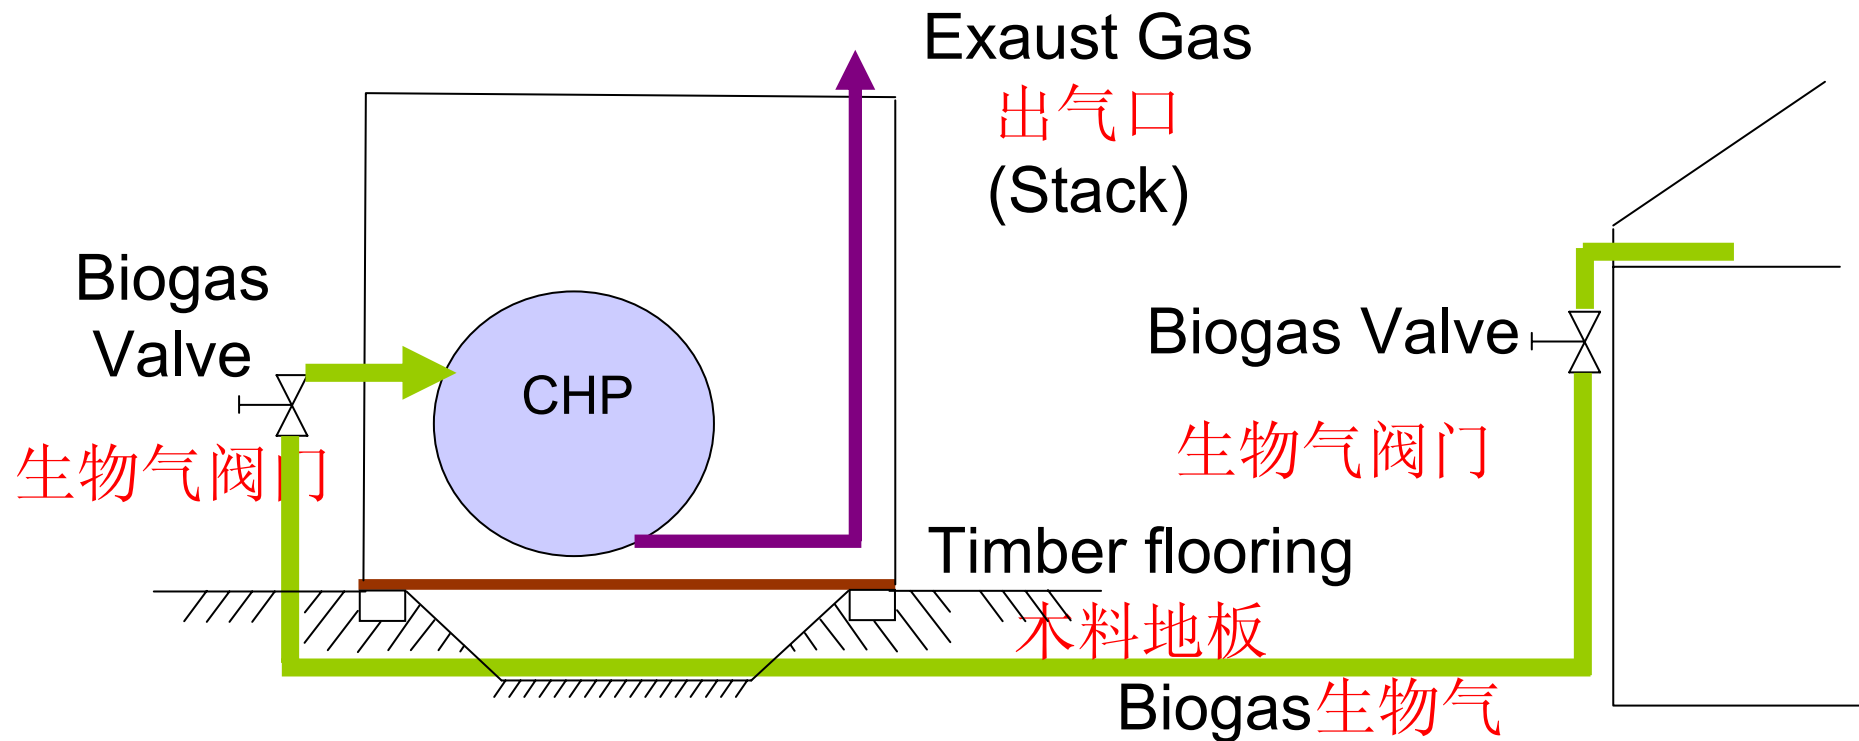
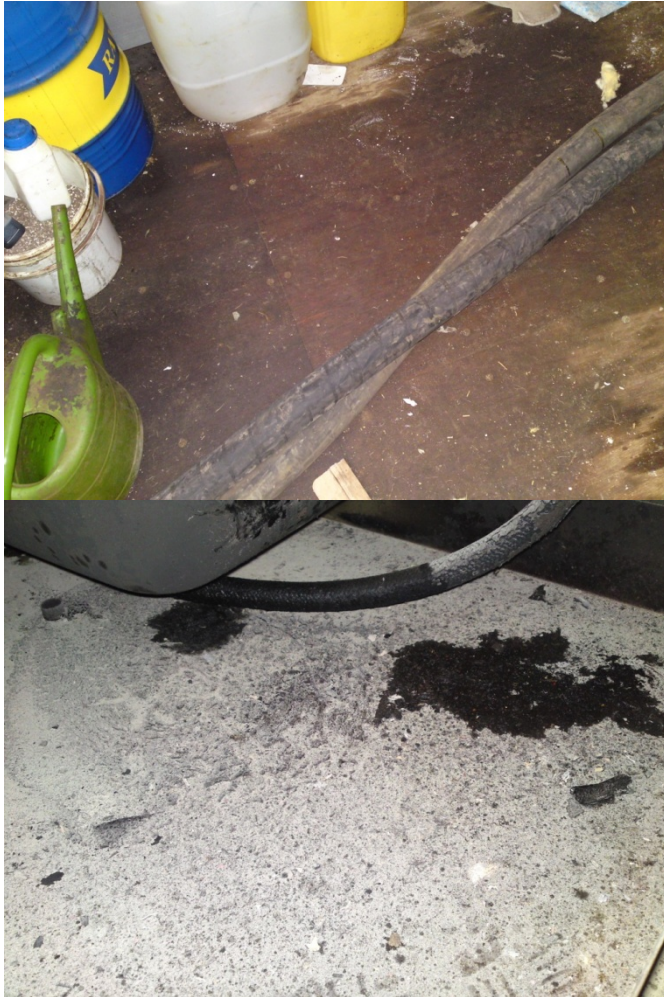
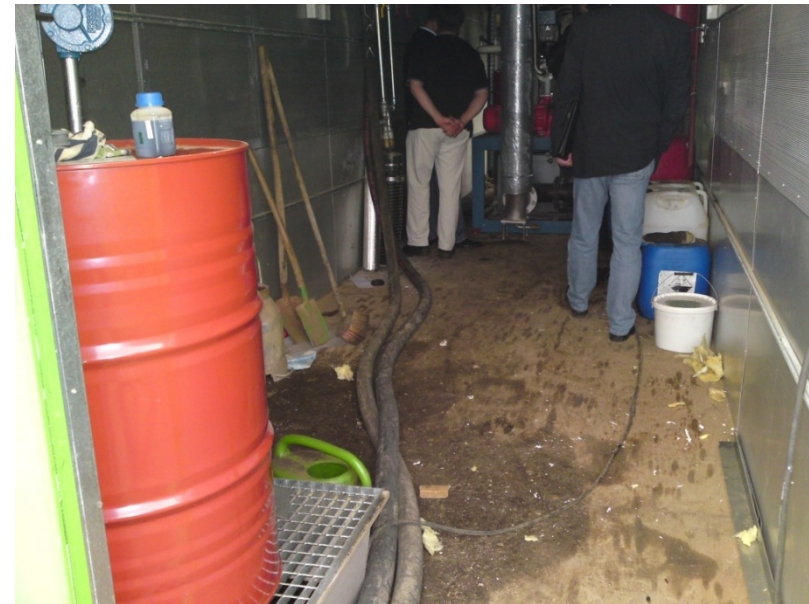
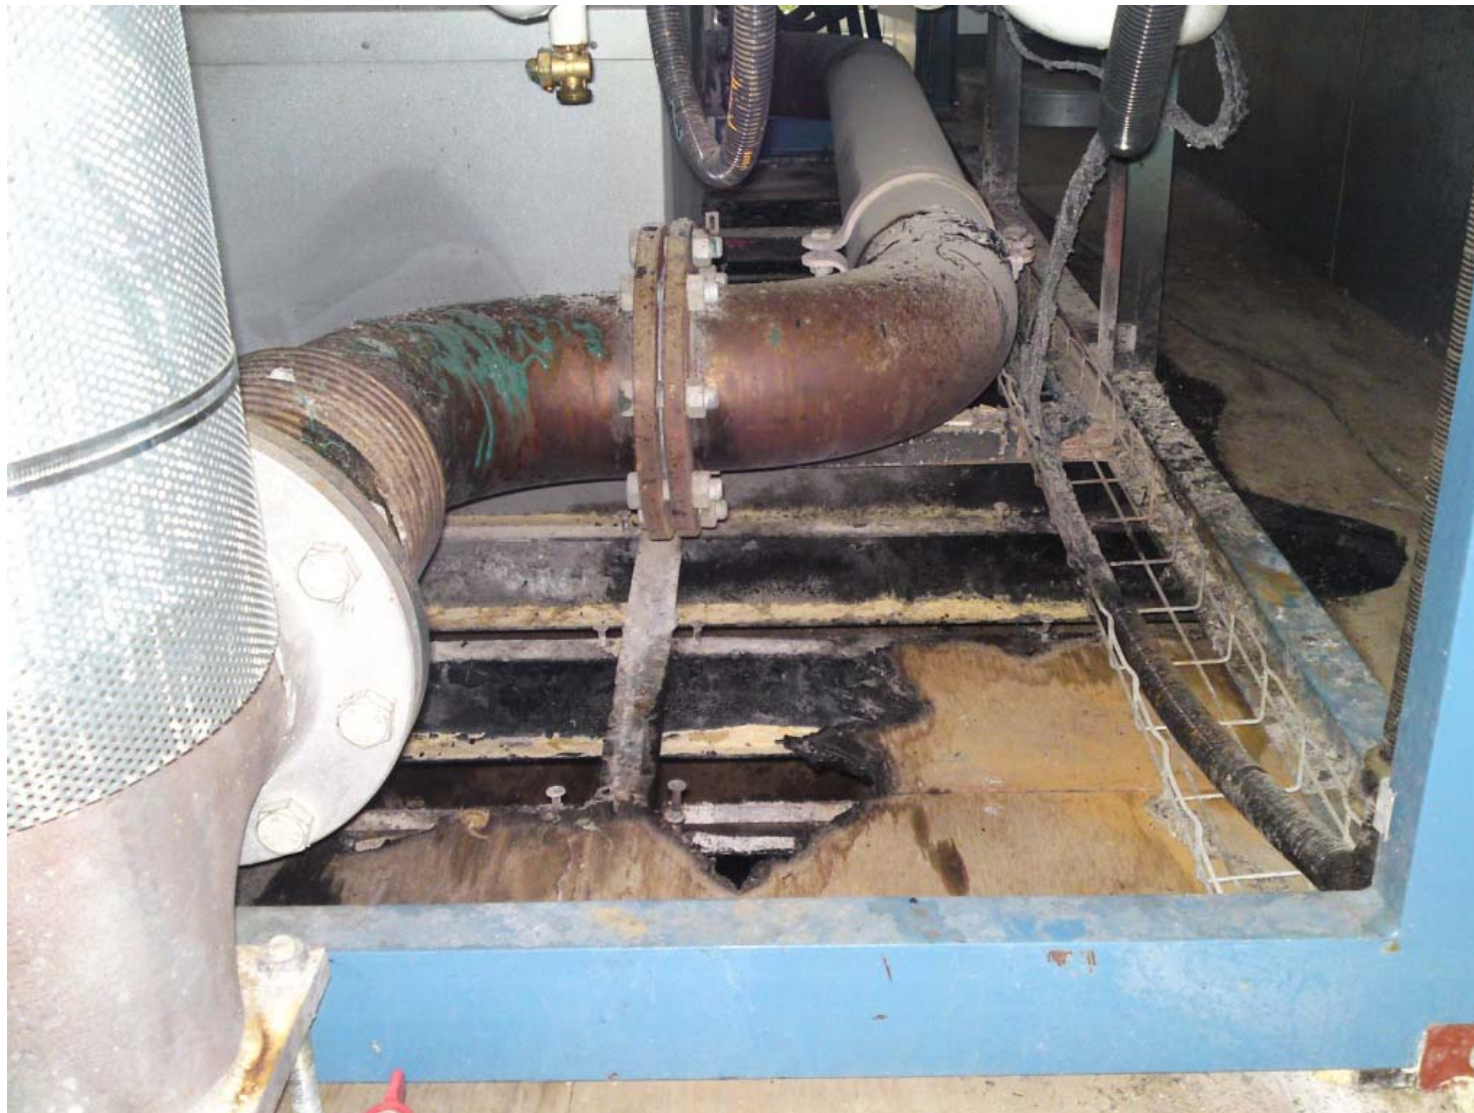
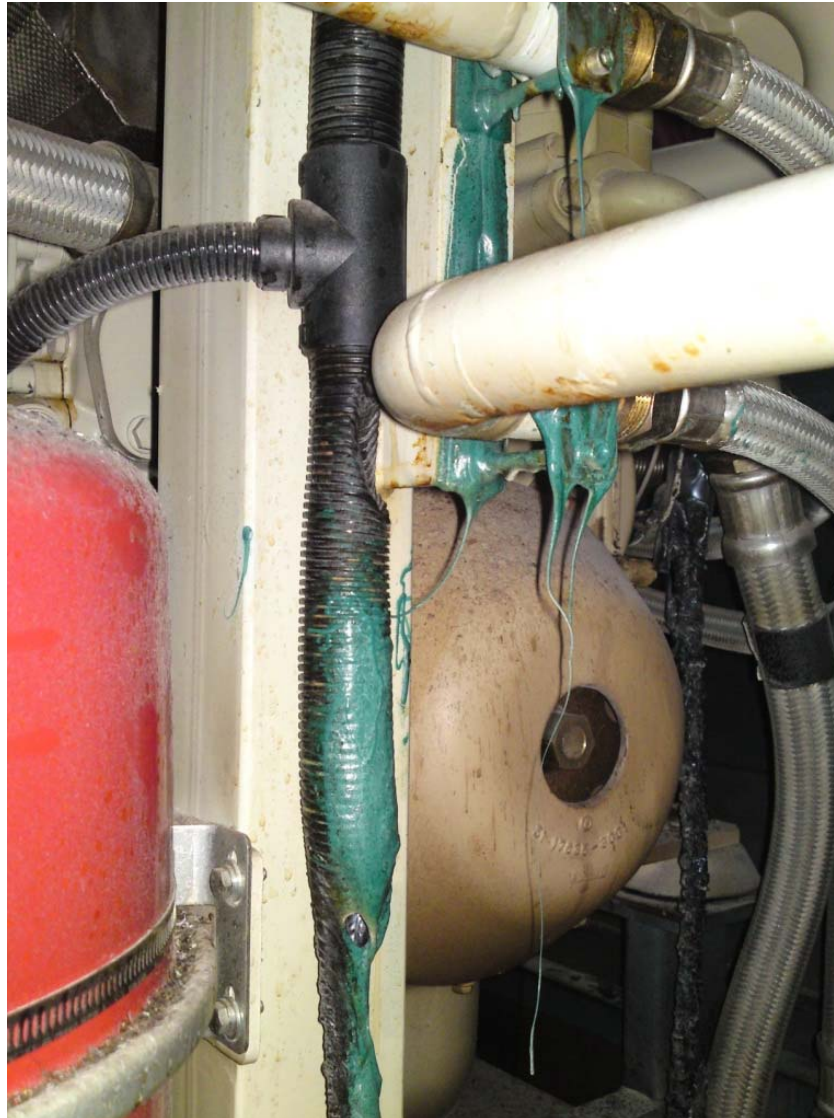
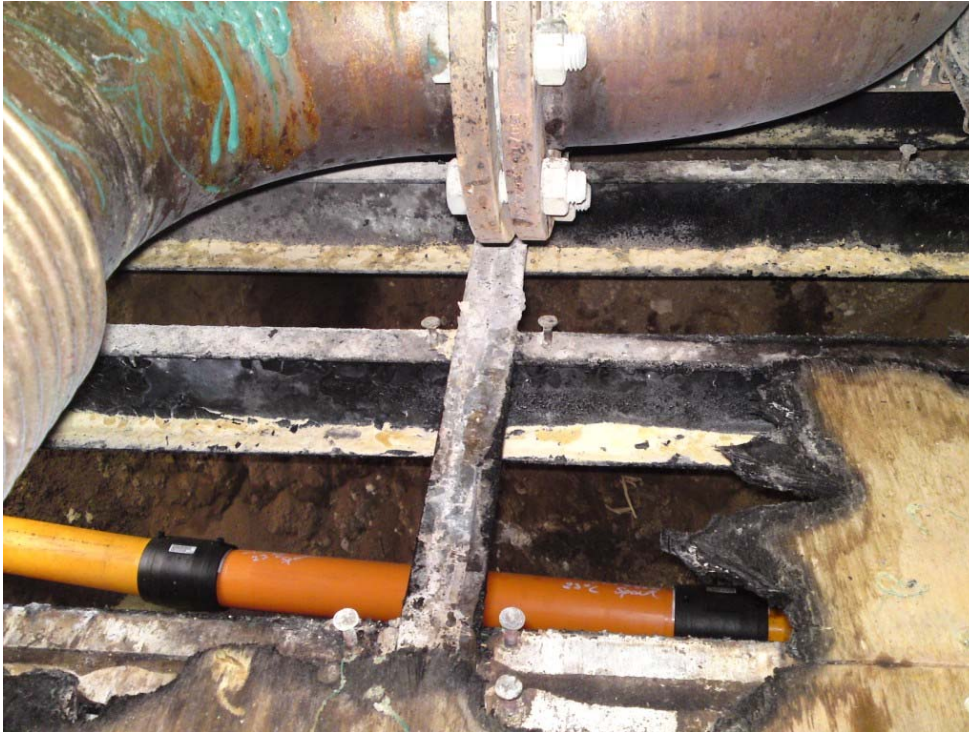
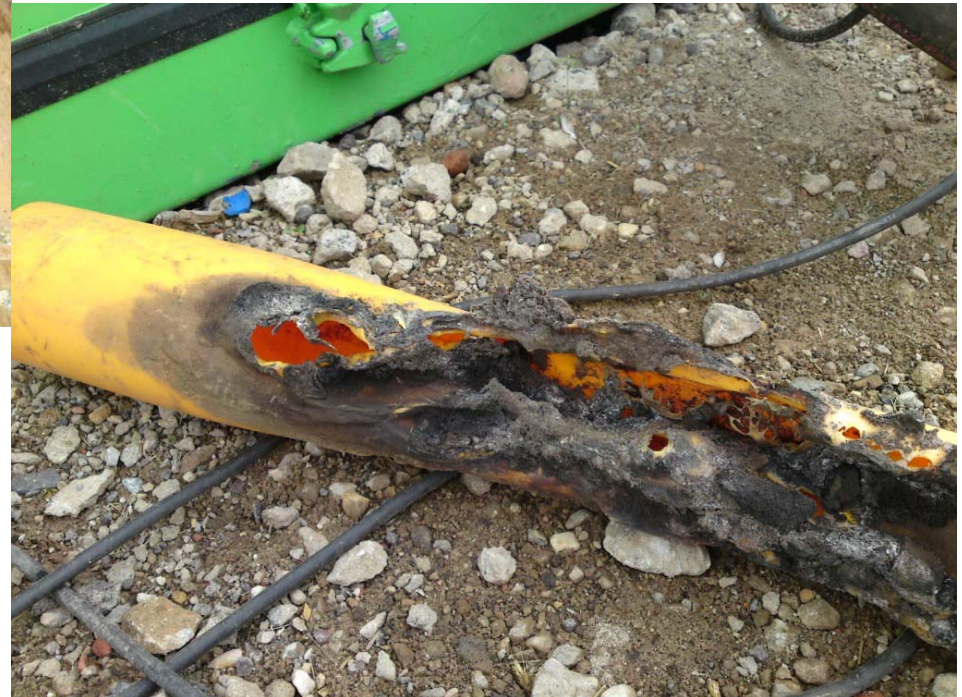
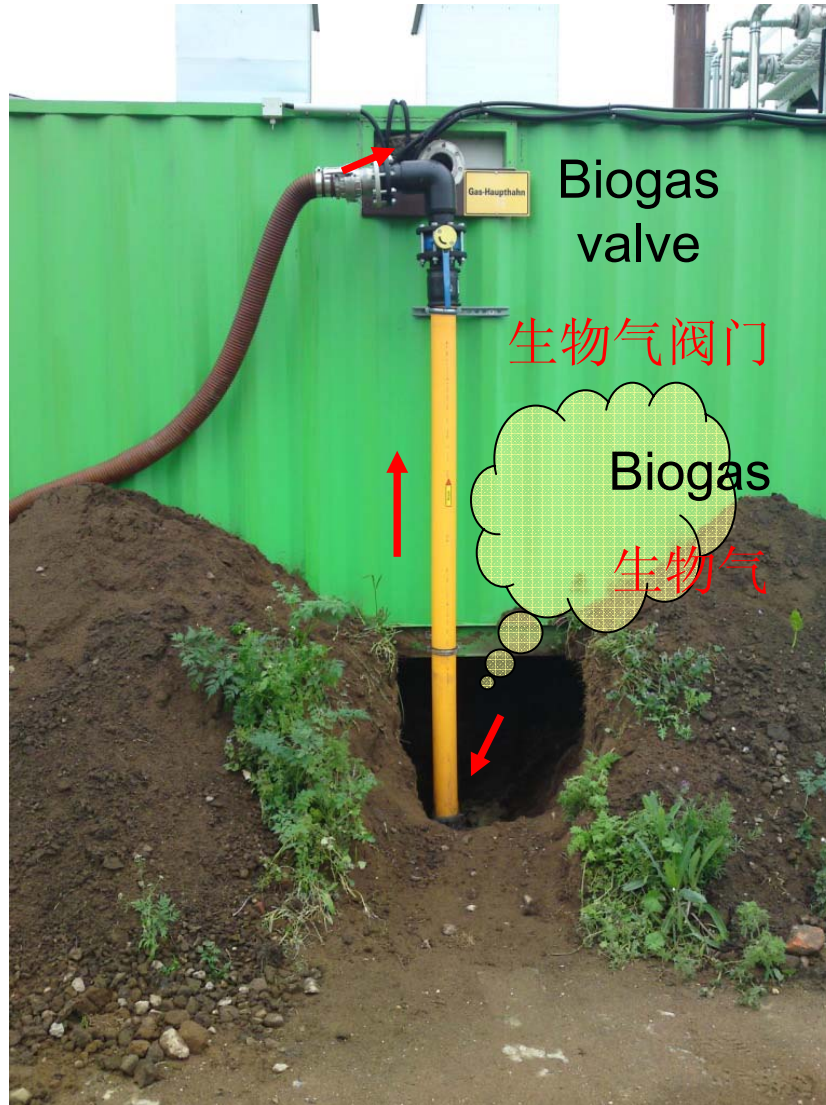
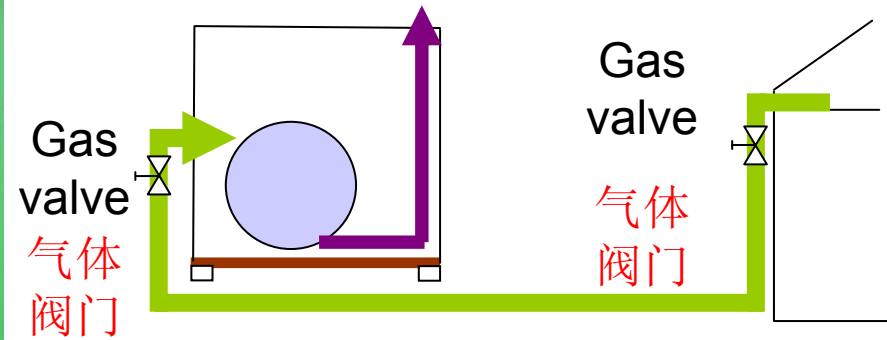
The CHP-container had a
timber flooring.

- Province-specified fire-protection regulations were not paid attention to
没有注重指定地区的防火保护法规
- Technical inadequateness:
技术不适宜（失败）
 - exhaust pipe did not keep the required distance (to the timber flooring and to the cables)
排气管也没有达到所需的距离（到木材地板和管道的距离）
 - exhaust pipe was not insulated against the timber flooring
排气管和木材地板之间不绝缘
 - biogas pipe below the container was not covered with soil
容器管道下的沼气管没有土壤覆盖
- The operator did not detect the reason of the fire
经营者没有找到火灾原因

- The damage has been categorized as extensive.
这种损害是广泛存在的
- The CHP-container has not been set up according to the actual regulations (province-specified fire- protection regulations are valid)
CHP容器没有根据实际规定建成（区域指定的消防保护法是有效的）
- No concerns have been expressed by the CHP provider
CHP提供商没有足够的重视
- Will the insurance pay the damage costs?
保险会为损害付赔偿金？

- Fire-protection regulations have to be paid attention to
必须注意防火法规
- The exhaust gas pipe has to keep safety distances or/and has to be insulated
废气管须保持安全距离和/或要绝缘
- To avoid accidents the engineering of a biogas plant should be done by a biogas specialist
为了避免意外事故，沼气专家应该负责沼气厂工程设计

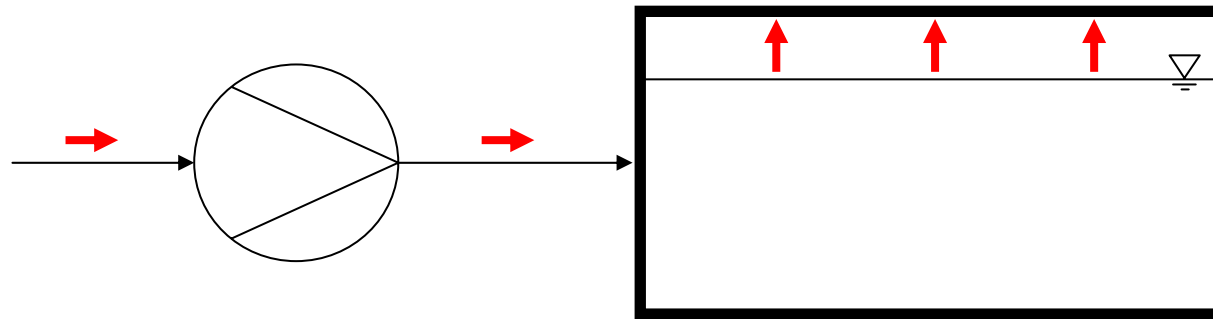
Screw
pump
螺丝泵

Concrete tank
混凝土池

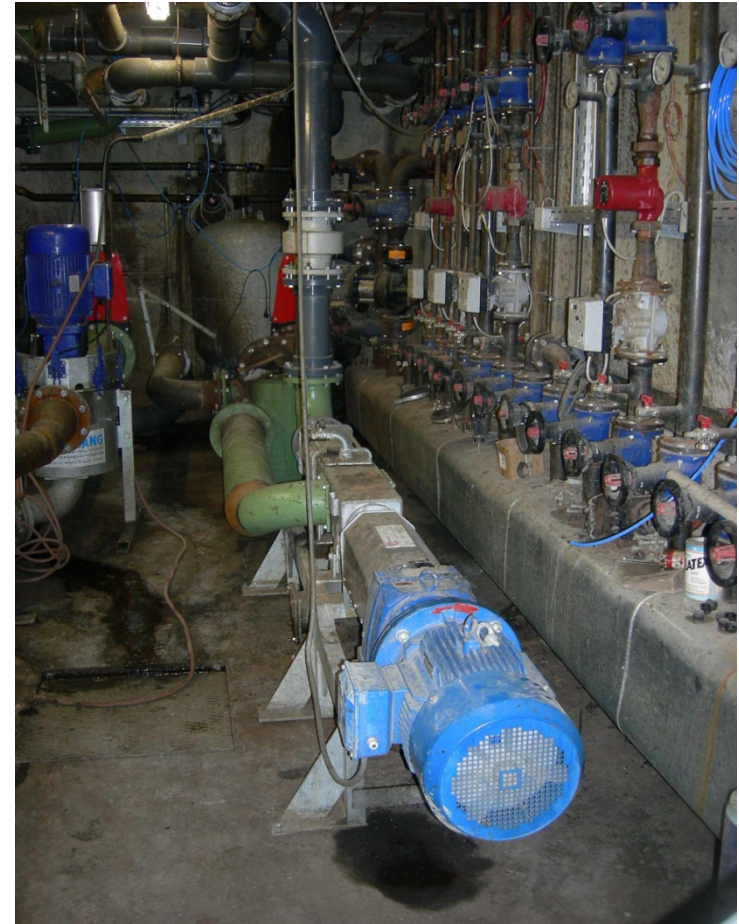
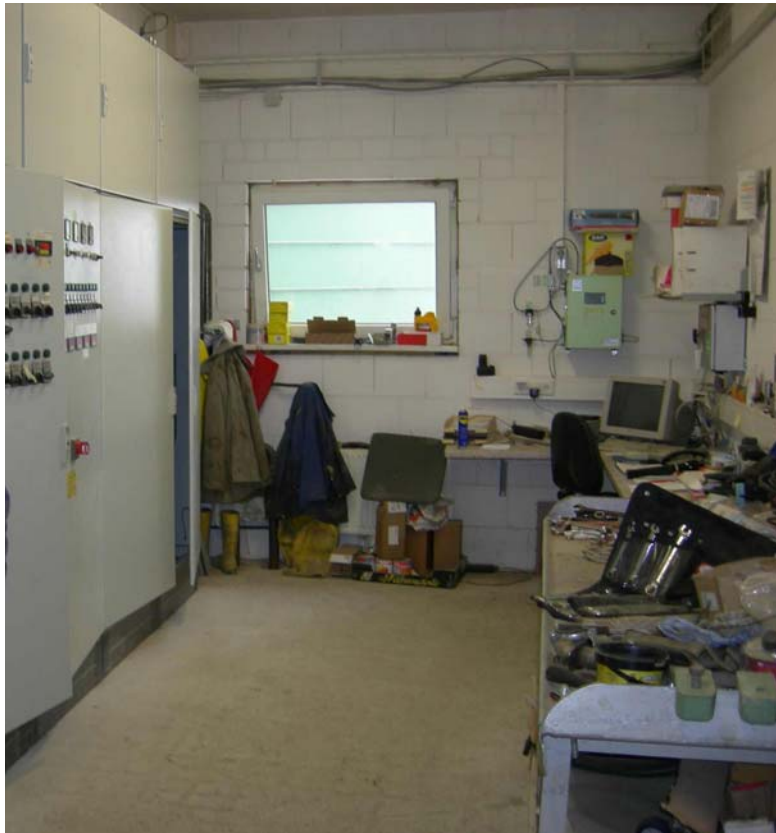
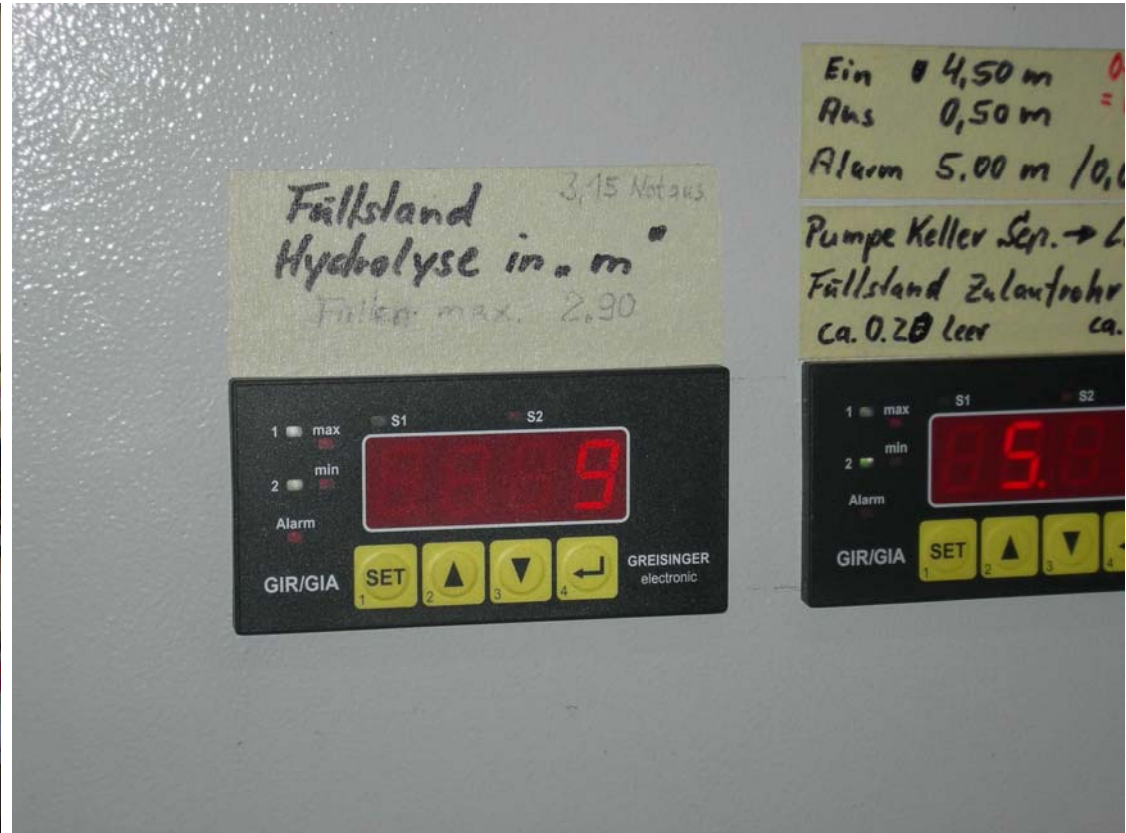
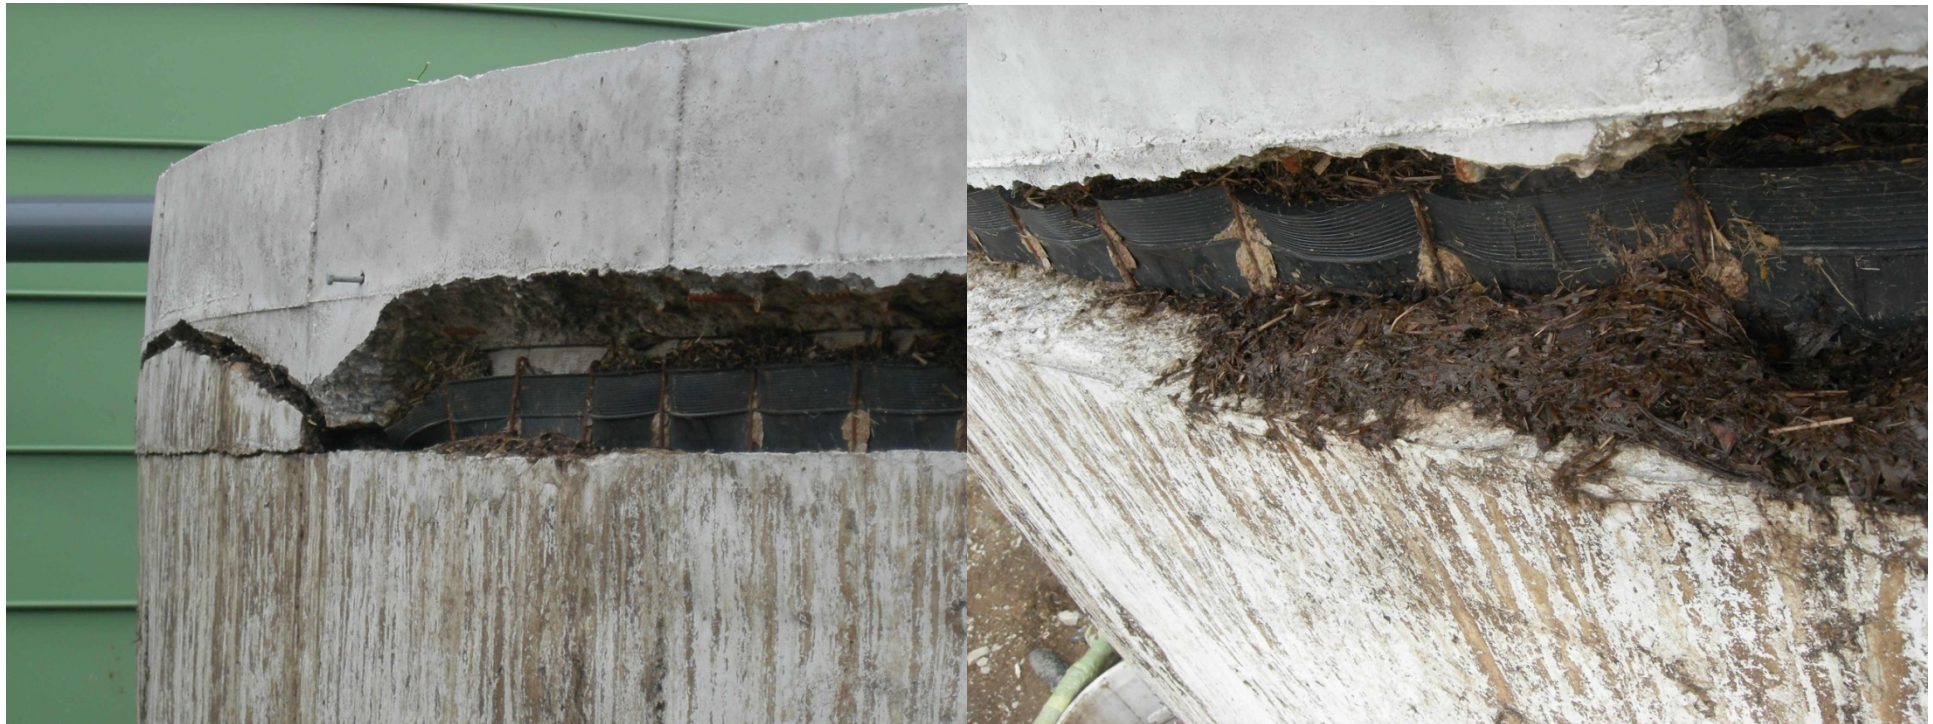
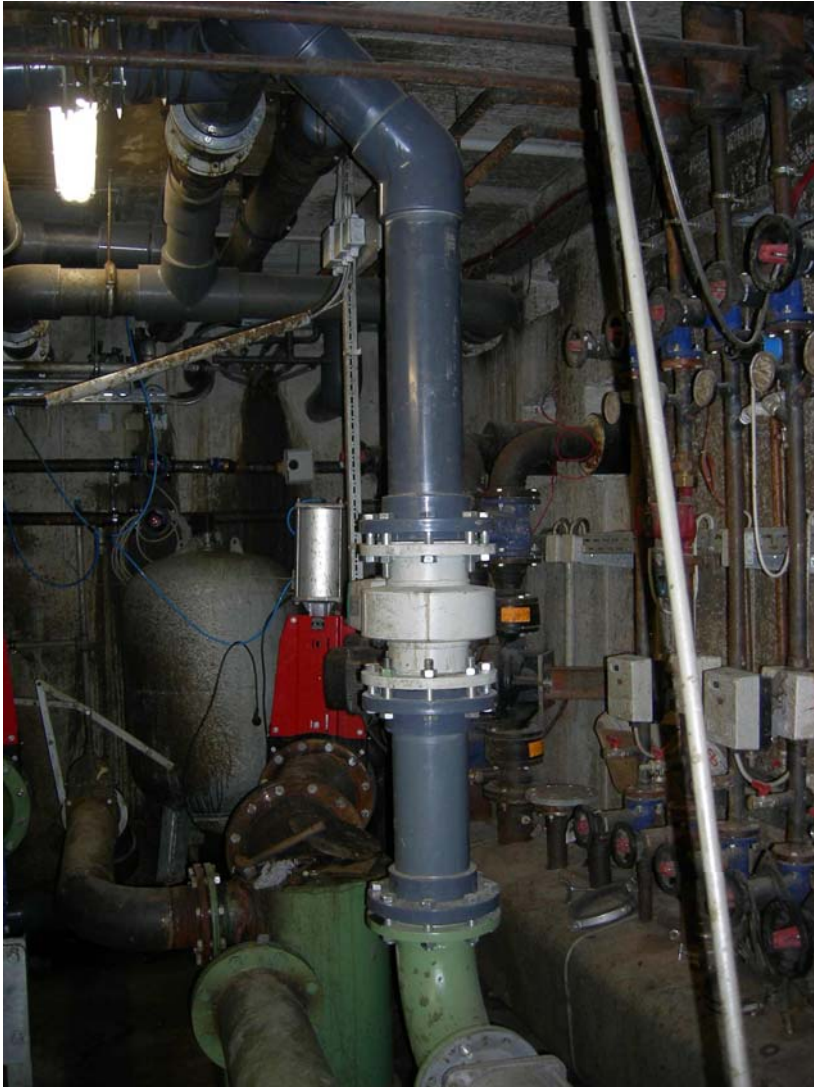
- No documentation of the plant
工厂没有记录
- No process flow sheet
没有工艺流程图
- Hydrolysis tank had been enhanced and equipped with a cover by the operator
水解池带盖子
- No structural calculation of the tank
池子没有进行结构计算
- No safety-regulated documentation
没有安全规章

- A precise documentation is important
需要一个详细的文件
- Safety devices have to be installed
需要安装安全设备
- The engineering of a biogas plant should be done by a biogas specialist
沼气专家应该负责生物气工厂的设计

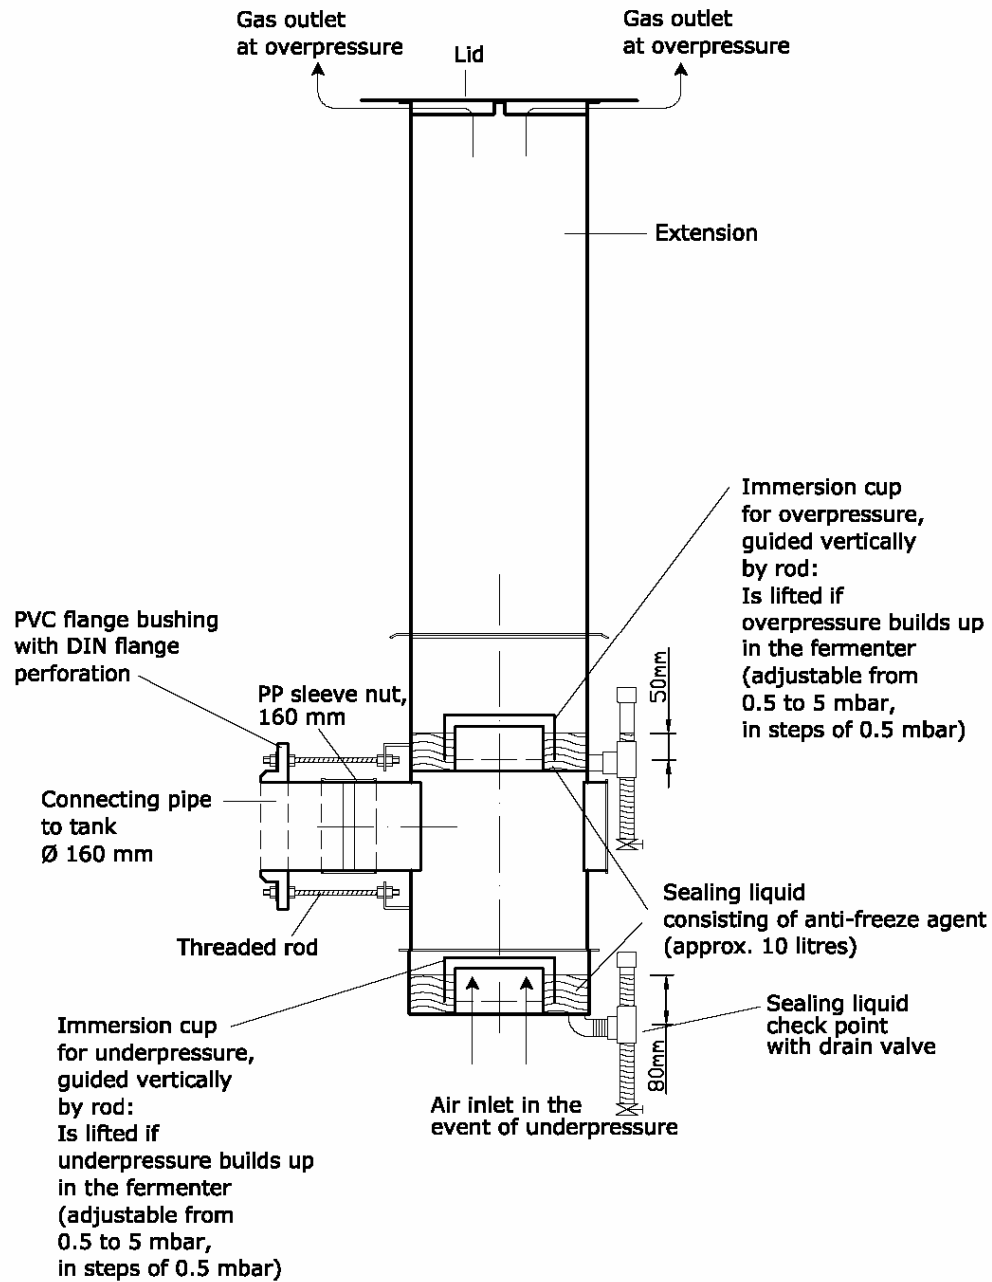
Principle of MT overpressure / vacuum valve with extension

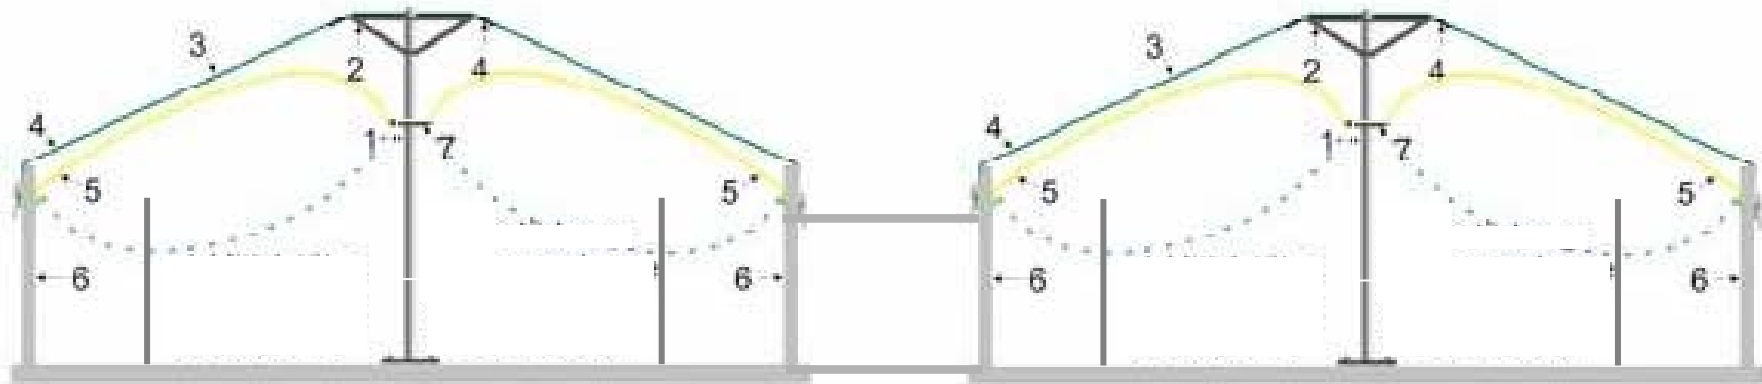
2 digesters identical in construction
